**Basic Seismological Characterization  
for  
Sheridan County, Wyoming**

James C. Case, Rachel N. Toner, and Robert Kirkwood  
Wyoming State Geological Survey  
September 2002

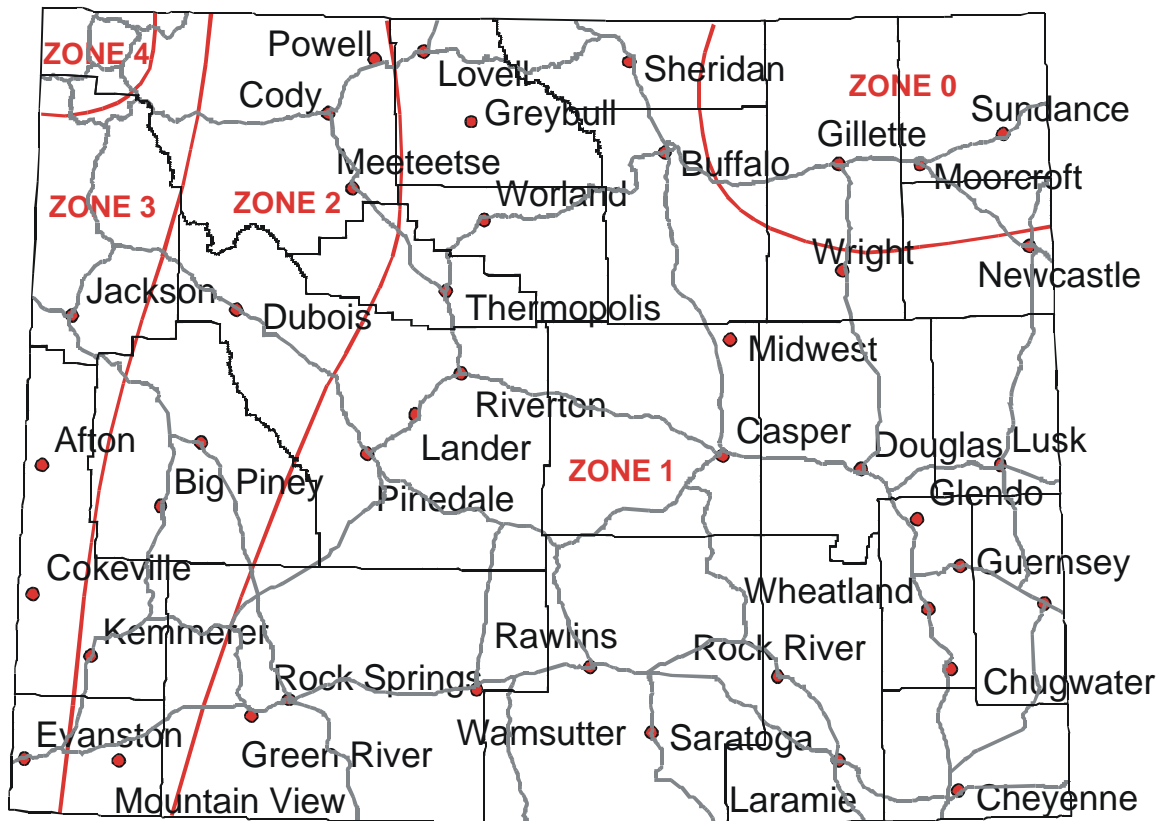
**Figure 1.** UBC Seismic Zone Map.

The current UBC Seismic Zone Map (Figure 1) (1997) has five seismic zones, ranging from Zone 0 to Zone 4, as can be seen on the enclosed map. The seismic zones are in part defined by the probability of having a certain level of ground shaking (horizontal acceleration) in 50 years. The criteria used for defining boundaries on the Seismic Zone Map were established by the Seismology Committee of the Structural Engineers Association of California (Building Standards, September-October, 1986). The criteria they developed are as follows:

Sheridan County is in Seismic Zones 0 and 1 of the UBC. Since effective peak accelerations (90% chance of non-exceedance in 50 years) can range from <5%-10% g in these two Zones, and there has been significant historic seismicity in the county, it may be reasonable to assume that an average peak acceleration of 5% g could be applied to the design of a non-critical facility located in the county if only the UBC were used. Such an acceleration, however, is significantly less than would be suggested through newer building codes.

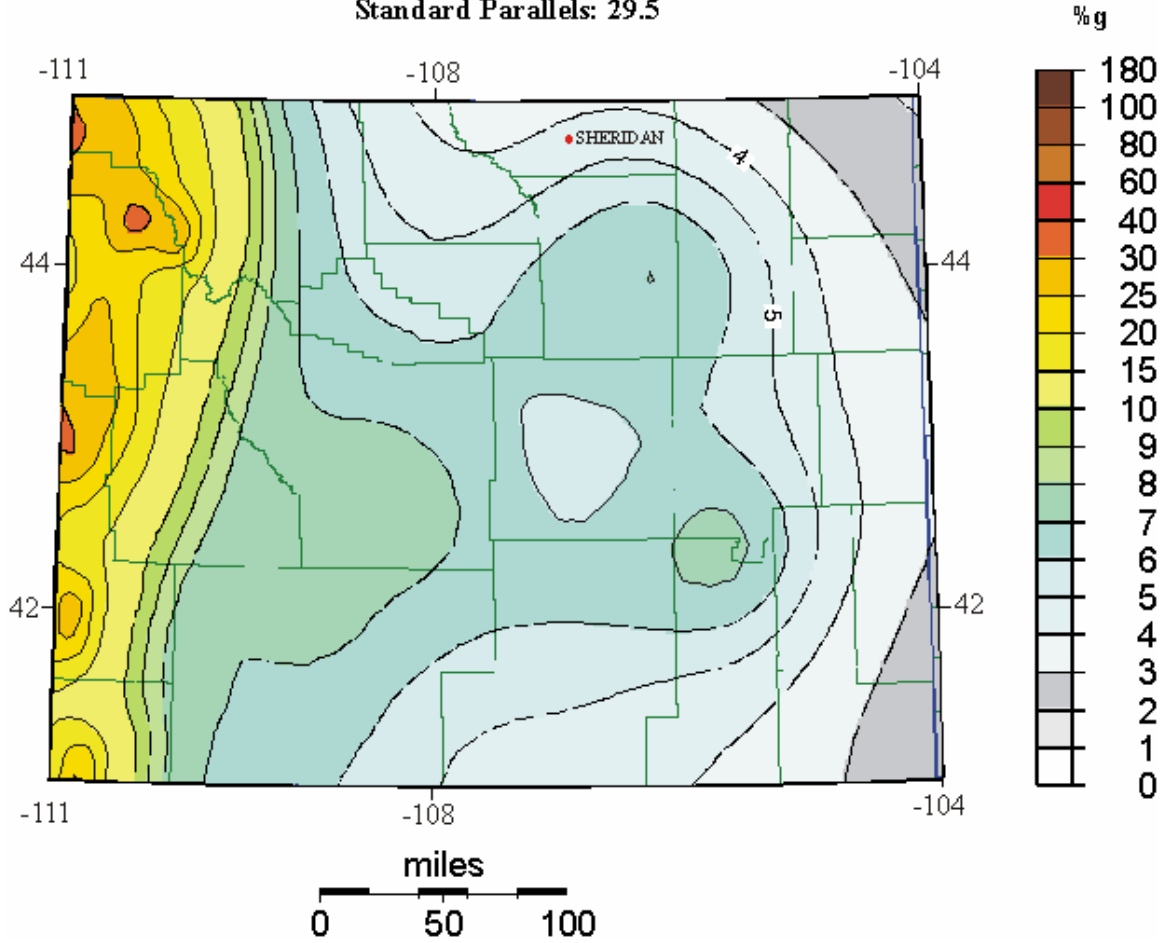
**Figure 2.** 500-year probabilistic acceleration map (10% probability of exceedance in 50 years).

Based upon the 500-year map (10% probability of exceedance in 50 years) (Figure 2), the estimated peak horizontal acceleration in Sheridan County ranges from 3%g in the northern portion of the county to over 5%g in the southern portion of the county. These accelerations are roughly comparable to intensity IV earthquakes (1.4%g – 3.9%g) to intensity V earthquakes (3.9%g - 9.2%g). Intensity IV earthquakes cause little damage. Intensity V earthquakes can result in cracked plaster and broken dishes. Sheridan would be subjected to an acceleration of approximately 4-5%g or intensity V.

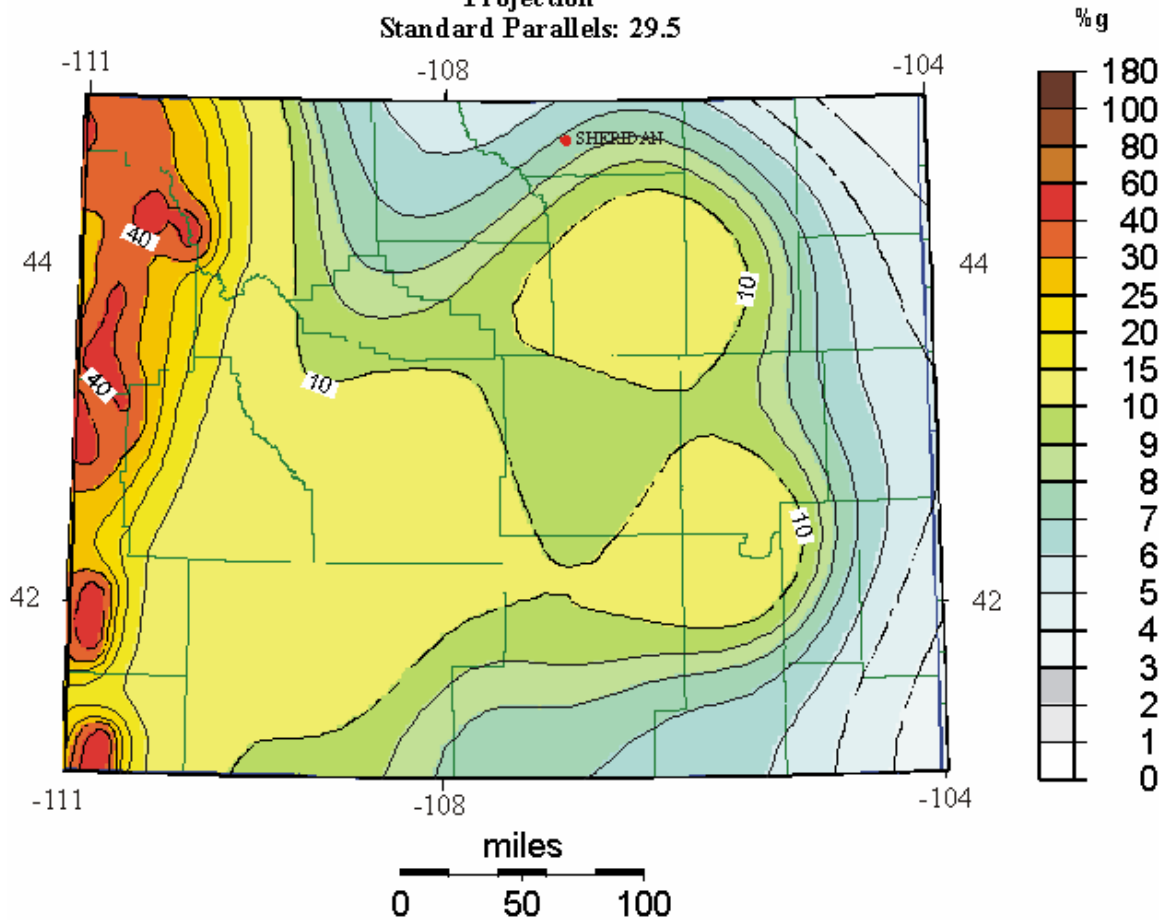
**Peak Acceleration (%g)  
with 5% Probability  
of Exceedance in 50 Years  
site: NEHRP B-C boundary**

**Figure 3.** 1000-year probabilistic acceleration map (5% probability of exceedance in 50 years).

Based upon the 1000-year map (5% probability of exceedance in 50 years) (Figure 3), the estimated peak horizontal acceleration in Sheridan County ranges from 5%g in the northwestern part of the county to over 9%g in the southeastern portion of the county. These accelerations are roughly comparable to intensity V earthquakes (3.9%g – 9.2%g). Intensity V earthquakes can result in cracked plaster and broken dishes. Sheridan would be subjected to an acceleration of approximately 7 - 8%g or intensity V.

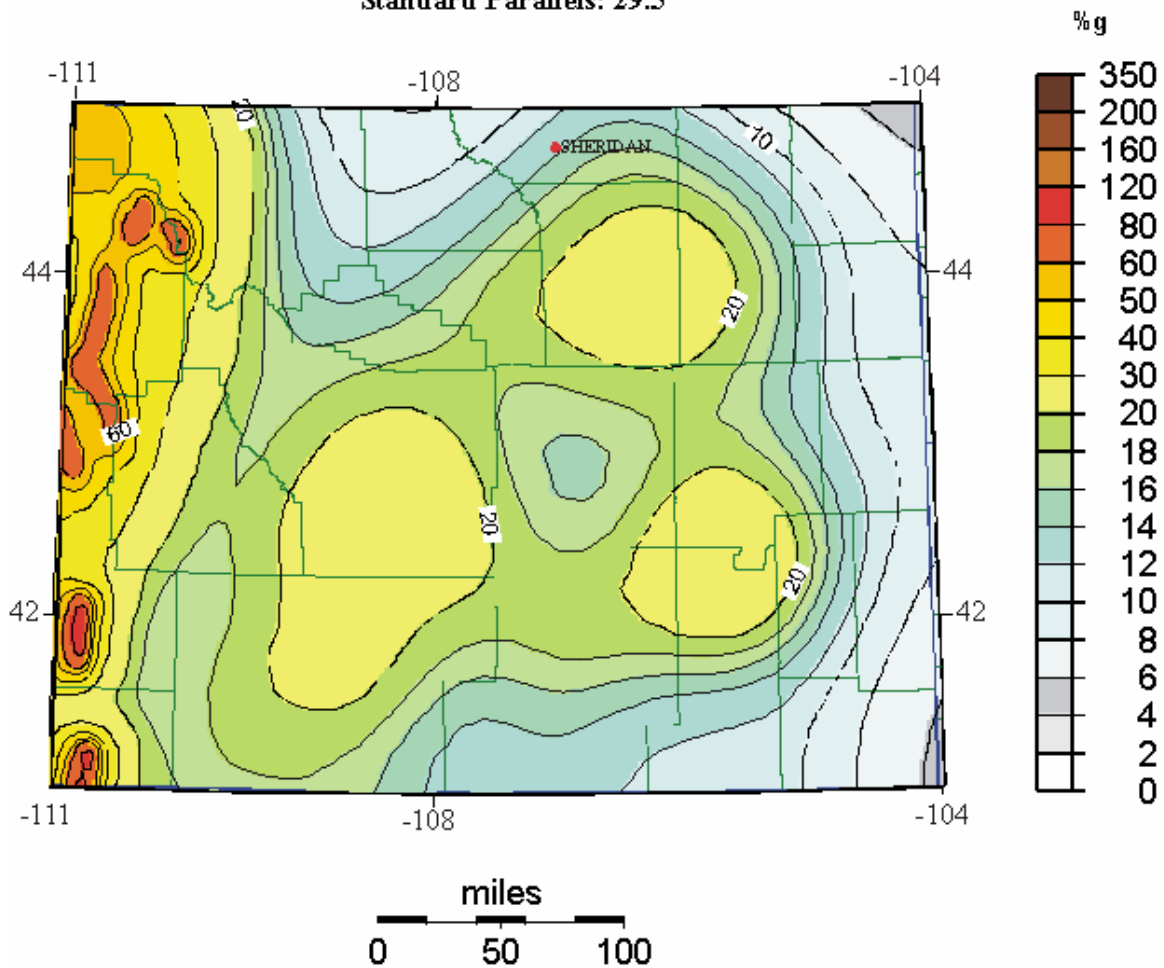
**Peak Acceleration (% g)  
with 2% Probability  
of Exceedance in 50 Years  
site: NEHRP B-C boundary**

**Figure 4.** 2500-year probabilistic acceleration map (2% probability of exceedance in 50 years).

Based upon the 2500-year map (2% probability of exceedance in 50 years) (Figure 4), the estimated peak horizontal acceleration in Sheridan County ranges from 9%g in the northwestern corner of the county to nearly 19%g in the southeastern corner of the county. These accelerations are roughly comparable to intensity V earthquakes (3.9%g – 9.2%g), intensity VI earthquakes (9.2%g – 18.0%g), and intensity VII earthquakes (18%g – 34%g). Intensity V earthquakes can result in cracked plaster and broken dishes. Intensity VI earthquakes can result in some heavy furniture can be moved. There may be some instances of fallen plaster and damaged chimneys. Intensity VII earthquakes can result in slight to moderate damage in well-built ordinary structures, and considerable damage in poorly built or badly designed structures, such as unreinforced masonry. Chimneys may be broken. Sheridan would be subjected to an acceleration of nearly 14%g or intensity VI.
