**Basic Seismological Characterization
for
Big Horn County, Wyoming**

James C. Case, Rachel N. Toner, and Robert Kirkwood
Wyoming State Geological Survey
September 2002

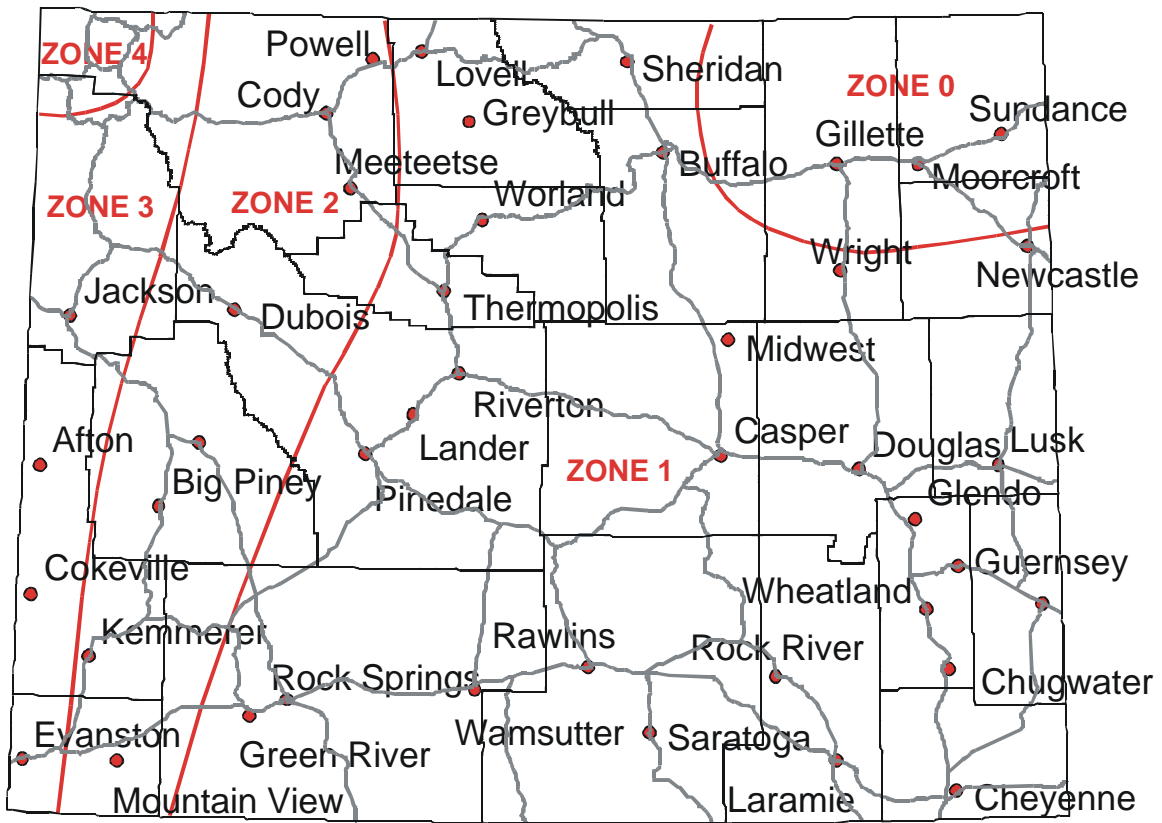
Figure 1. UBC Seismic Zone Map.

The current UBC Seismic Zone Map (Figure 1) (1997) has five seismic zones, ranging from Zone 0 to Zone 4, as can be seen on the enclosed map. The seismic zones are in part defined by the probability of having a certain level of ground shaking (horizontal acceleration) in 50 years. The criteria used for defining boundaries on the Seismic Zone Map were established by the Seismology Committee of the Structural Engineers Association of California (Building Standards, September-October, 1986). The criteria they developed are as follows:

Big Horn County is primarily in Seismic Zone 1 of the UBC, although the far western portion of the county is in Seismic Zone 2. Since effective peak accelerations (90% chance of non-exceedance in 50 years) can range from 5%g-10%g in these two zones, and there has been some

significant historic seismicity in the county, it may be reasonable to assume that an average peak acceleration of 10.0%g could be applied to the design of a non-critical facility located in the county if only the UBC were used. Such acceleration, however, is significantly less than would be suggested through newer building codes.

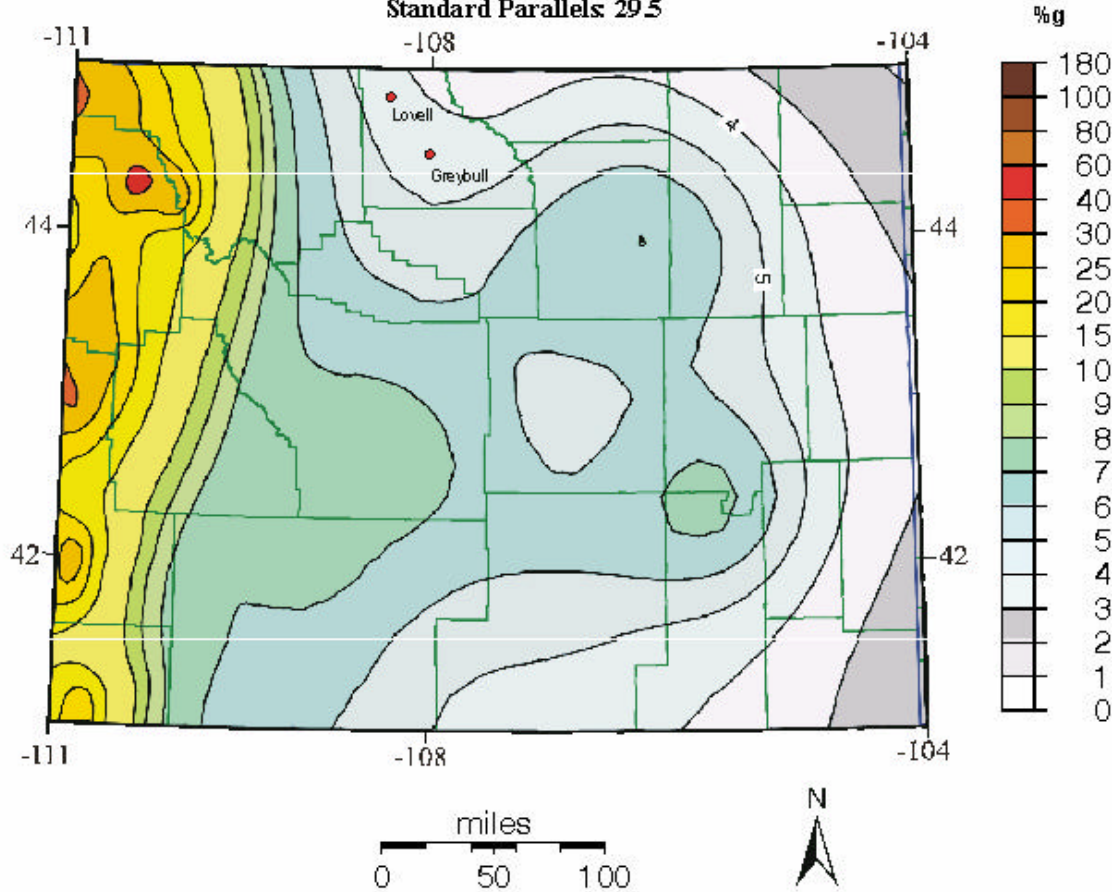
Figure 2. 500-year probabilistic acceleration map (10% probability of exceedance in 50 years).

Based upon the 500-year map (10% probability of exceedance in 50 years) (Figure 2), the estimated peak horizontal acceleration in Big Horn County ranges from approximately 3%g in the northeastern corner of the county to nearly 6%g in the southern portion of the county. These accelerations are roughly comparable to intensity IV earthquakes (1.4%g - 3.9%g) to intensity V earthquakes (3.9%g – 9.2%g). These accelerations are comparable to the accelerations to be expected in Seismic Zone 1 of the Uniform Building Code. Intensity IV earthquakes cause little damage. Intensity V earthquakes can result in cracked plaster and broken dishes. Lovell and Greybull would be subjected to accelerations of approximately 4-5%g or intensity V.

**Peak Acceleration (%g)
with 10% Probability
of Exceedance in 50 Years
site: NEHRP B-C boundary**

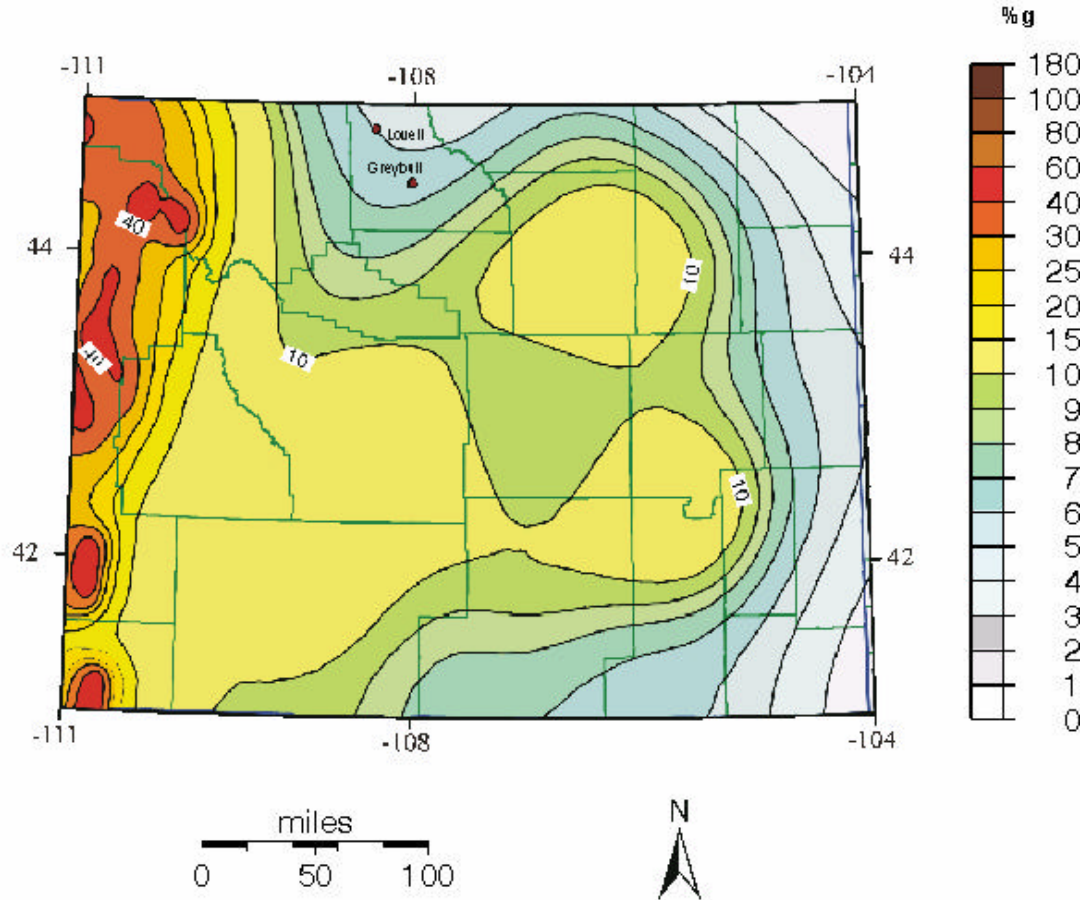
Figure 3. 1000-year probabilistic acceleration map (5% probability of exceedance in 50 years).

Based upon the 1000-year map (5% probability of exceedance in 50 years) (Figure 3), the estimated peak horizontal acceleration in Big Horn County ranges from 5%g in the northern portion of the county to nearly 10%g in the southeastern part of the county. These accelerations are roughly comparable to intensity V earthquakes (3.9%g – 9.2%g) to intensity VI earthquakes (9.2%g – 18%g). Intensity V earthquakes can result in cracked plaster and broken dishes. Intensity VI earthquakes can result in fallen plaster and damaged chimneys. Lovell and Greybull would be subjected to accelerations of approximately 6%g and 7%g, respectively, or intensity V.

**Peak Acceleration (%g)
with 5% Probability
of Exceedance in 50 Years
site: NEHRP B-C boundary**

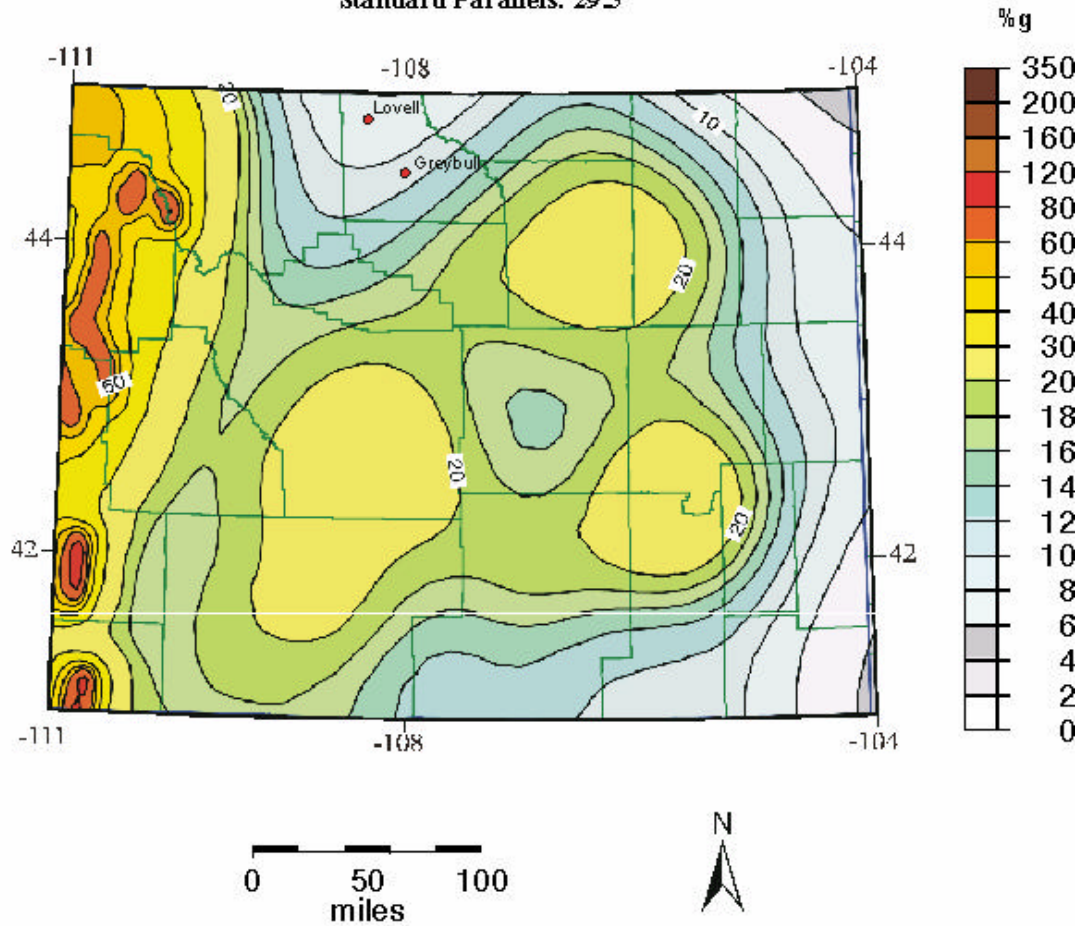
Figure 4. 2500-year probabilistic acceleration map (2% probability of exceedance in 50 years).

Based upon the 2500-year map (2% probability of exceedance in 50 years) (Figure 4), the estimated peak horizontal acceleration in Big Horn County ranges from approximately 8%g in the northern portion of the county to over 18%g in the southeastern corner of the county. These accelerations are roughly comparable to intensity V earthquakes (3.9%g – 9.2%g), intensity VI earthquakes (9.2%g – 18%g), and intensity VII earthquakes (18%g – 34%g). Intensity V earthquakes can result in cracked plaster and broken dishes. Intensity VI earthquakes can result in fallen plaster and damaged chimneys. Intensity VII earthquakes can result in slight to moderate damage in well-built ordinary structures, and considerable damage in poorly built or badly designed structures, such as unreinforced masonry. Chimneys may be broken. Lovell and Greybull would be subjected to accelerations of approximately 9%g and 12%g, respectively, or intensity VI.

**Peak Acceleration (% g)
with 2% Probability
of Exceedance in 50 Years
site: NEHRP B-C boundary**

As the historic record is limited, it is nearly impossible to determine when a 2,500-year event last occurred in the county. Because of the uncertainty involved, and based upon the fact that the new International Building Code utilizes 2,500-year events for building design, it is suggested that the 2,500-year probabilistic maps be used for Big Horn County analyses. This conservative approach is in the interest of public safety.
