**Basic Seismological Characterization
for
Crook County, Wyoming**

James C. Case, Rachel N. Toner, and Robert Kirkwood
Wyoming State Geological Survey
September 2002

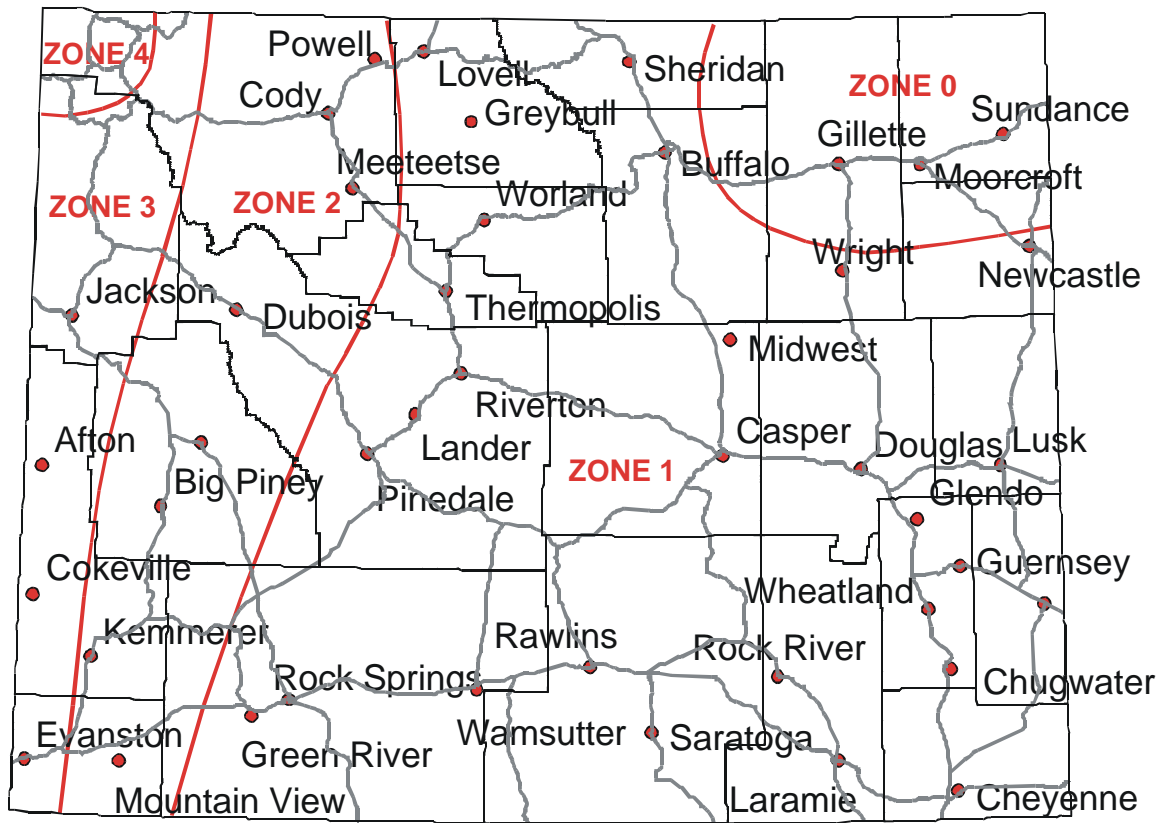
Figure 1. UBC Seismic Zone Map.

The current UBC Seismic Zone Map (Figure 1) (1997) has five seismic zones, ranging from Zone 0 to Zone 4, as can be seen on the enclosed map. The seismic zones are in part defined by the probability of having a certain level of ground shaking (horizontal acceleration) in 50 years. The criteria used for defining boundaries on the Seismic Zone Map were established by the Seismology Committee of the Structural Engineers Association of California (Building Standards, September-October, 1986). The criteria they developed are as follows:

Crook County is in Seismic Zone 0 of the UBC. Since effective peak accelerations (90% chance of non-exceedance in 50 years) can range from 0%-5%g in Zone 0, and there has been some significant historic seismicity in the county, it may be reasonable to assume that a maximum peak acceleration of 5.0%g could be applied to the design of a non-critical facility located in the county if only the UBC were used. Such an acceleration, however, is significantly less than would be suggested through newer building codes.

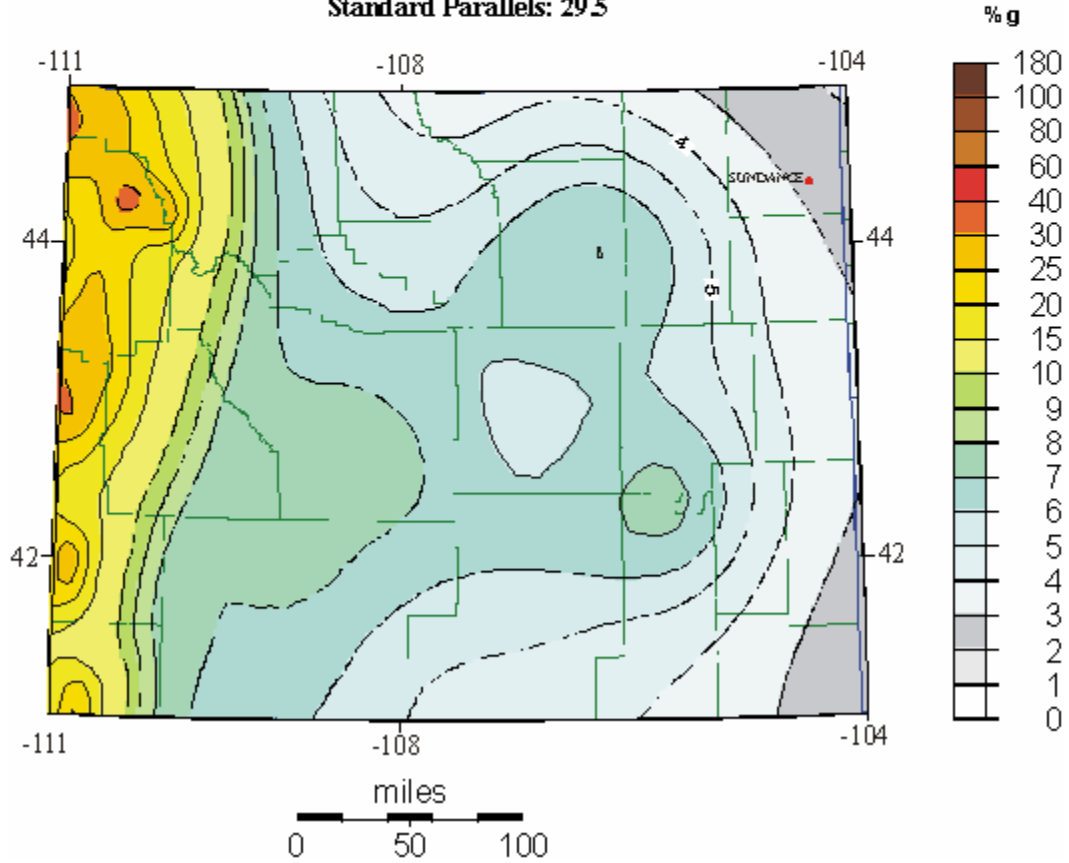
Figure 2. 500-year probabilistic acceleration map (10% probability of exceedance in 50 years).

Based upon the 500-year map (10% probability of exceedance in 50 years) (Figure 2), the estimated peak horizontal acceleration in Crook County ranges from approximately 2%g in the northeastern corner of the county to greater than 4%g in the southwestern corner of the county. These accelerations are roughly comparable to intensity IV earthquakes (1.4%g – 3.9%g) to intensity V earthquakes (3.9%g – 9.2%g). Intensity IV earthquakes cause little damage. Intensity V earthquakes can result in cracked plaster and broken dishes. Sundance would be subjected to an acceleration of approximately 2 - 3%g or intensity IV.

**Peak Acceleration (%g)
with 10% Probability
of Exceedance in 50 Years
site: NEHRP B-C boundary**

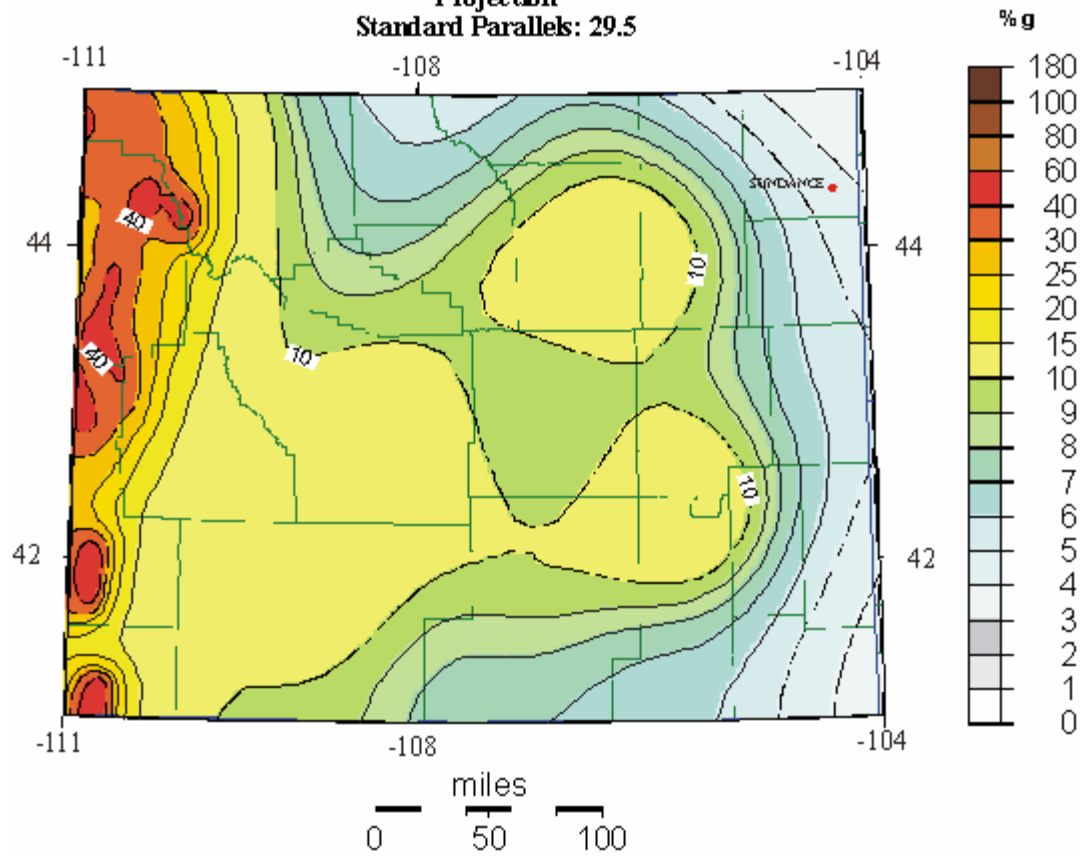
Figure 3. 1000-year probabilistic acceleration map (5% probability of exceedance in 50 years).

Based upon the 1000-year map (5% probability of exceedance in 50 years) (Figure 3), the estimated peak horizontal acceleration in Crook County ranges from approximately 3%g in the northeastern corner of the county to greater than 7%g in the extreme southwestern corner of the county. These accelerations are roughly comparable to intensity V earthquakes (3.9%g – 9.2%g). Intensity V earthquakes can result in cracked plaster and broken dishes. Sundance would be subjected to an acceleration of approximately 4-5%g or intensity V.

**Peak Acceleration (% g)
with 5% Probability
of Exceedance in 50 Years
site: NEHRP B-C boundary**

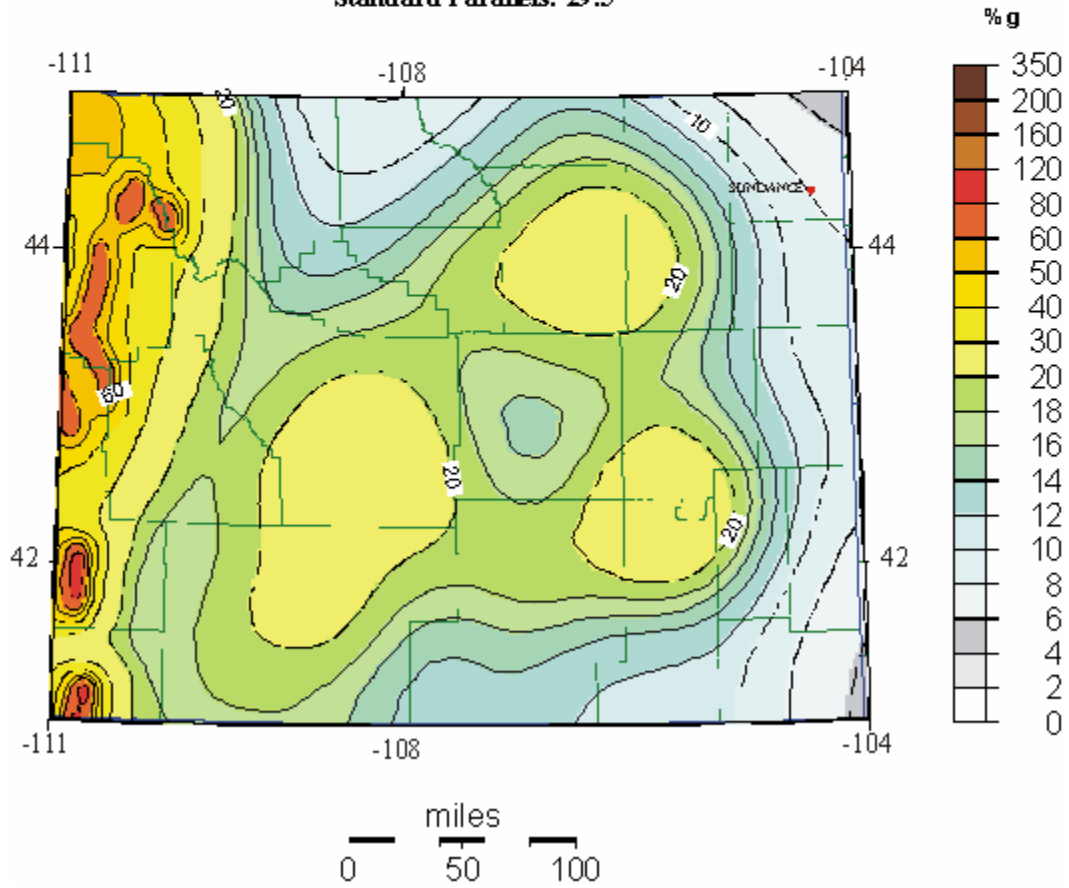
Figure 4. 2500-year probabilistic acceleration map (2% probability of exceedance in 50 years).

Based upon the 2500-year map (2% probability of exceedance in 50 years) (Figure 4), the estimated peak horizontal acceleration in Crook County ranges from approximately 5%g in the northeastern corner of the county to nearly 14%g in the southwestern corner of the county. These accelerations are roughly comparable to intensity V earthquakes (3.9%g – 9.2%g) to

intensity VI earthquakes (9.2%g – 18%g). Intensity V earthquakes can result in cracked plaster and broken dishes. Intensity VI earthquakes can result in fallen plaster and damaged chimneys. Sundance would be subjected to an acceleration of approximately 8%g or intensity V.

**Peak Acceleration (%g)
with 2% Probability
of Exceedance in 50 Years
site: NEHRP B-C boundary**

As the historic record is limited, it is nearly impossible to determine when a 2,500-year event last occurred in the county. Because of the uncertainty involved, and based upon the fact that the new International Building Code utilizes 2,500-year events for building design, it is suggested that the 2,500-year probabilistic maps be used for Crook County analyses. This conservative approach is in the interest of public safety.
