**Basic Seismological Characterization
for
Goshen County, Wyoming**

James C. Case, Rachel N. Toner, and Robert Kirkwood
Wyoming State Geological Survey
September 2002

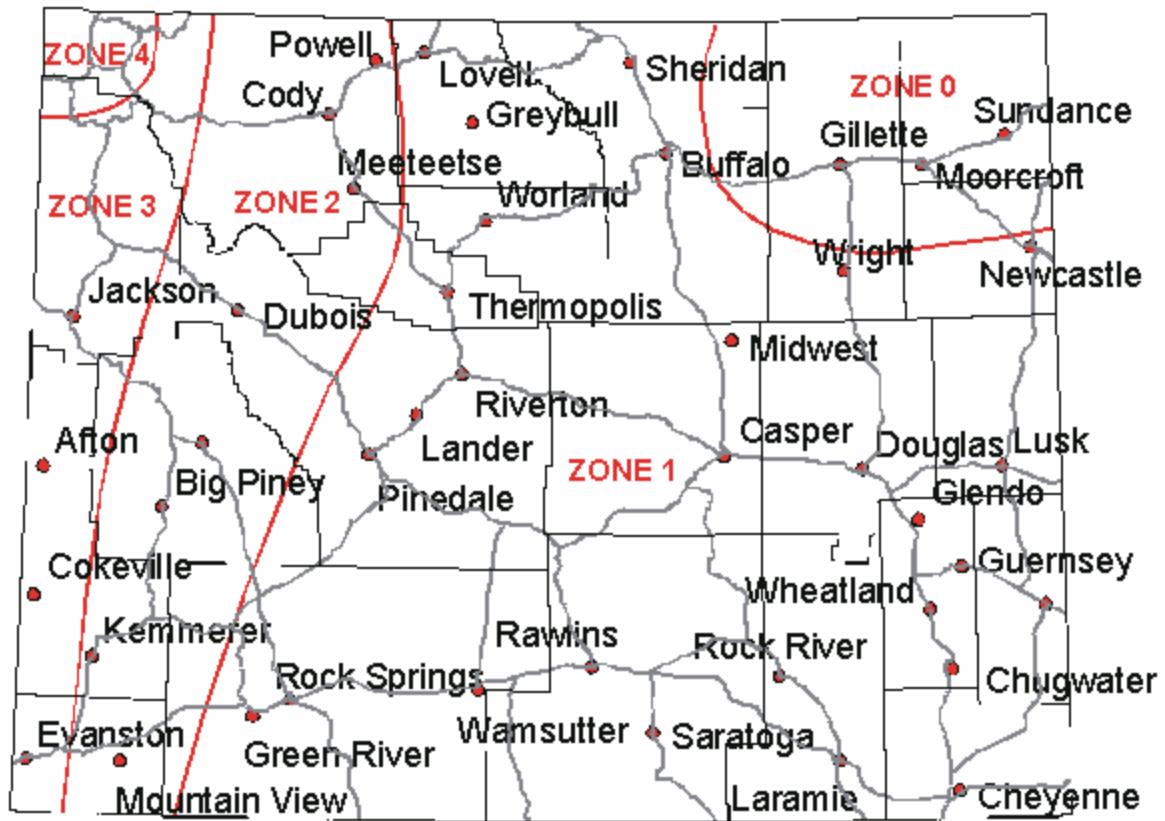
Figure 1. UBC Seismic Zone Map.

The current UBC Seismic Zone Map (Figure 1) (1997) has five seismic zones, ranging from Zone 0 to Zone 4, as can be seen on the enclosed map. The seismic zones are in part defined by the probability of having a certain level of ground shaking (horizontal acceleration) in 50 years. The criteria used for defining boundaries on the Seismic Zone Map were established by the Seismology Committee of the Structural Engineers Association of California (Building Standards, September-October, 1986). The criteria they developed are as follows:

Goshen County is in Seismic Zone 1 of the UBC. Since effective peak accelerations (90% chance of non-exceedance in 50 years) can range from 5%-10%g in this zone, and there has been some historic seismicity in the county, it may be reasonable to assume that a maximum peak acceleration of 10.0%g could be applied to the design of a non-critical facility located in the county if only the UBC were used. Such an acceleration, however, is less than would be suggested through newer building codes.

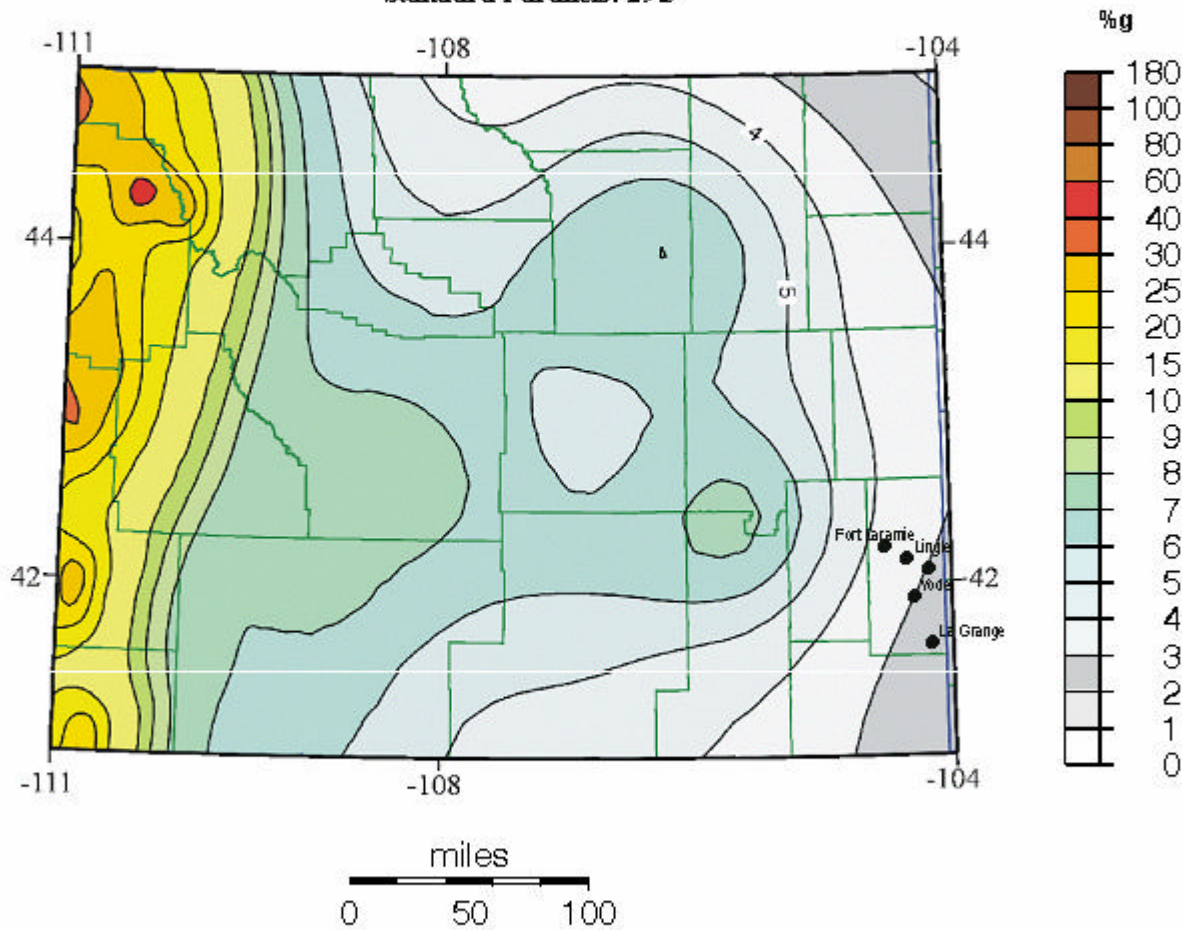
Figure 2. 500-year probabilistic acceleration map (10% probability of exceedance in 50 years).

Based upon the 500-year map (10% probability of exceedance in 50 years) (Figure 2), the estimated peak horizontal acceleration in Goshen County ranges from approximately 2%g in the

southeastern corner of the county to greater than 4%g in the northwestern corner of the county. These accelerations are roughly comparable to intensity IV earthquakes (1.4%g – 3.9%g) and intensity V earthquakes (3.9%g – 9.2%g). Intensity IV earthquakes cause little damage. Intensity V earthquakes can result in cracked plaster and broken dishes. Torrington would be subjected to an acceleration of approximately 3%g or intensity IV.

**Peak Acceleration (%g)
with 10% Probability
of Exceedance in 50 Years
site: NEHRP B-C boundary**

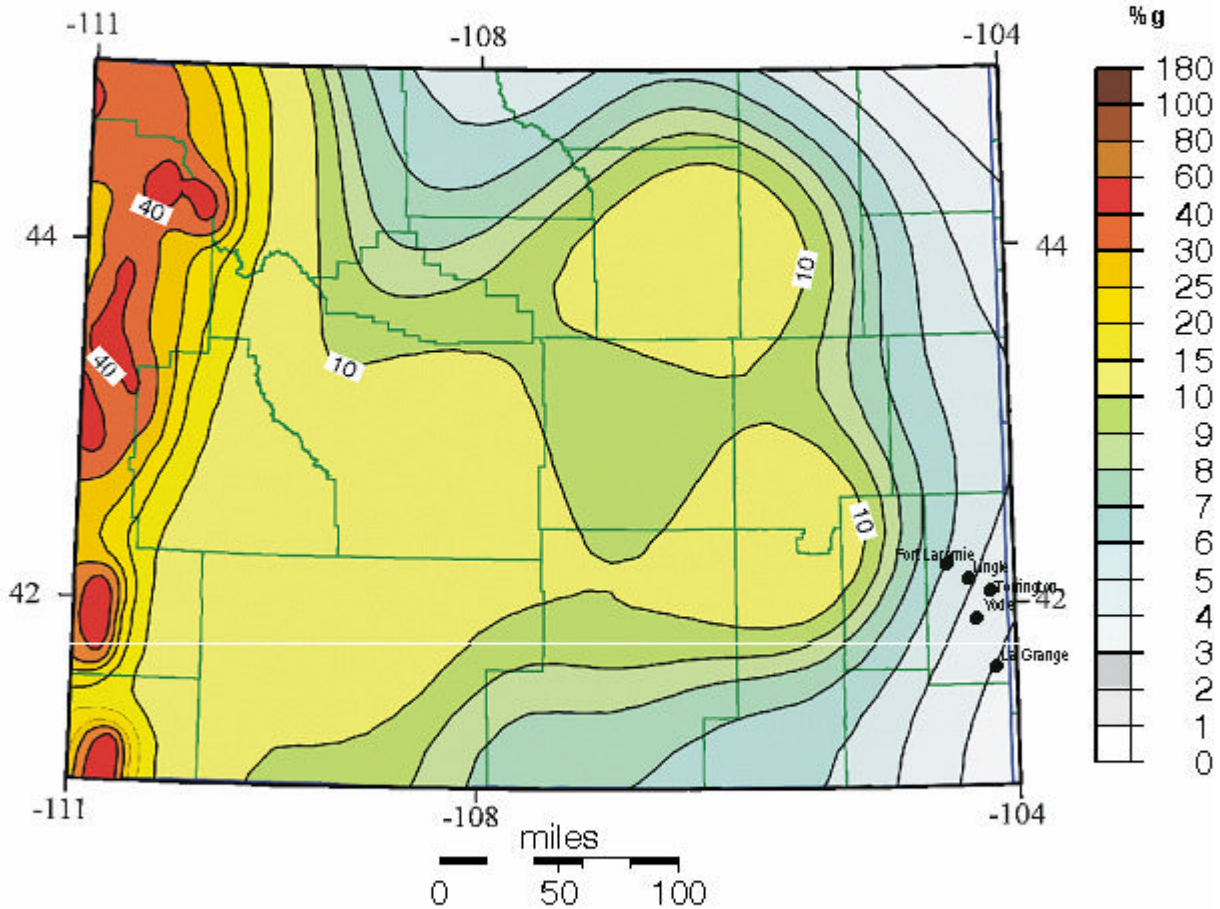
Figure 3. 1000-year probabilistic acceleration map (5% probability of exceedance in 50 years).

Based upon the 1000-year map (5% probability of exceedance in 50 years) (Figure 3), the estimated peak horizontal acceleration in Goshen County ranges from 3%g in the southeastern corner of the county to 7%g in the northwestern corner of the county. These accelerations are roughly comparable to intensity IV earthquakes (1.4%g – 3.9%g) and intensity V earthquakes (3.9%g – 9.2%g). Intensity IV earthquakes cause little damage. Intensity V earthquakes can result in cracked plaster and broken dishes. Torrington would be subjected to an acceleration of approximately 4-5%g or intensity V.

**Peak Acceleration (%g)
with 5% Probability
of Exceedance in 50 Years
site: NEHRP B-C boundary**

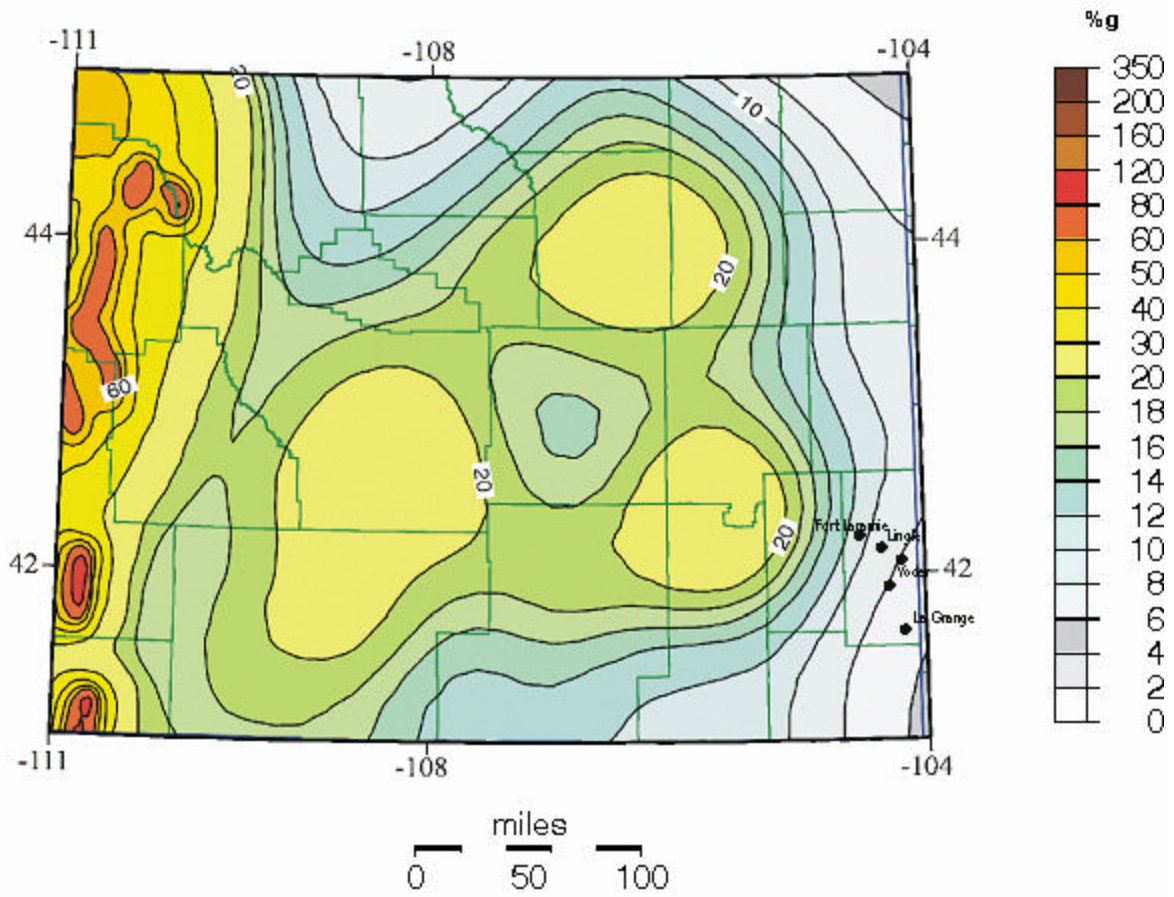
Figure 4. 2500-year probabilistic acceleration map (2% probability of exceedance in 50 years).

Based upon the 2500-year map (2% probability of exceedance in 50 years) (Figure 4), the estimated peak horizontal acceleration in Goshen County ranges from 7%g in the southeastern corner of the county to greater than 12%g in the northwestern corner of the county. These accelerations are roughly comparable to intensity V earthquakes (3.9%g – 9.2%g) and intensity VI earthquakes (9.2%g – 18%g). Intensity V earthquakes can result in cracked plaster and broken dishes. Intensity VI earthquakes can result in fallen plaster and damaged chimneys. Torrington would be subjected to an acceleration of approximately 8%g or intensity V.

**Peak Acceleration (%g)
with 2% Probability
of Exceedance in 50 Years
site: NEHRP B-C boundary**

As the historic record is limited, it is nearly impossible to determine when a 2,500-year event last occurred in the county. Because of the uncertainty involved, and based upon the fact that the new International Building Code utilizes 2,500-year events for building design, it is suggested that the 2,500-year probabilistic maps be used for Goshen County analyses. This conservative approach is in the interest of public safety.
